# A technique for anchor plug salvage in the setting of a cold welded taper adapter following compress implant failure

**Abstract:** The Compress implant is used to achieve compliant fixation for endoprosthetic reconstruction during limb salvage. Failures, when they occur, are typically at the bone-implant interface. We describe a case of implant failure at a modular junction near a cold-welded taper adapter, blocking access to the spindle nut. Salvage of the anchor plug was performed in this case to avoid re-cutting the remaining bone.

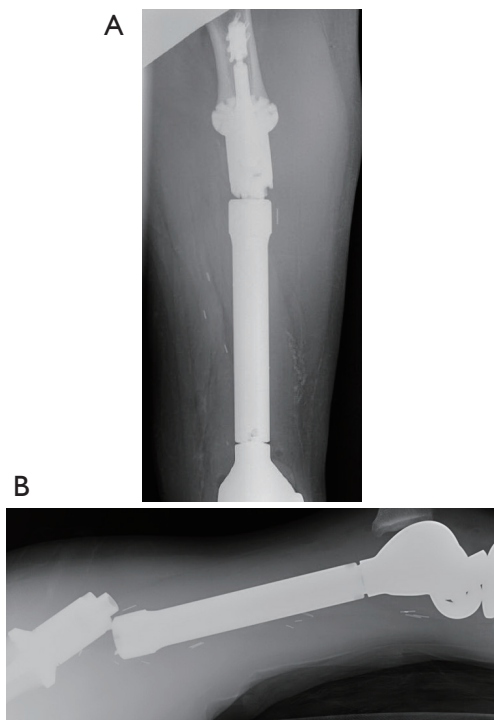
After scrutinizing the films, it was clear that the mechanism of failure was fracture of the male portion of the taper adapter adjacent to where it entered the diaphyseal segment (*Figure 1B*). The simplest possible surgery, therefore, would involve disengaging the taper adapter from the Compress spindle, replacing it with a new adapter, and replacing the diaphyseal segment. This strategy would retain the existing Compress, which was felt to be important in order to maintain the length of the short segment of native bone proximally.

**Figure 1** AP (A) and lateral (B) radiographs of the patient on presentation, demonstrating mechanical failure of the taper adapter at its junction with the diaphyseal segment.

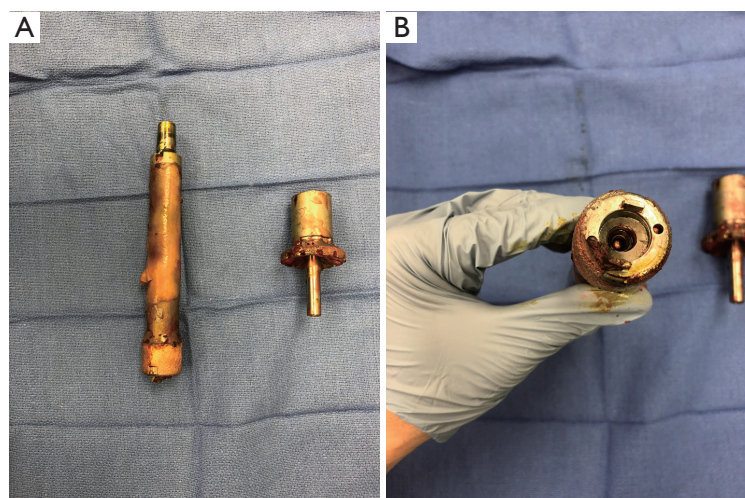
expose the implant and proximal femur. The fracture was identified, and confirmed to be at the male portion of the taper adapter (*Figure 2*). We attempted to disengage the taper adapter from the spindle, but deformed two pitch-fork removal devices in the process and failed to remove it using a bone tamp. It became clear at this point that the two implants were cold-welded together. There were two reasonable options: (I) the entire Compress device could be removed, which would require identifying and removing the anchor pins, disrupting the implant-bone interface, and re-cutting the proximal femur or (II) we could attempt to remove only the spindle and centering sleeve, leaving the existing anchor plug in place. The second option was favorable as it would minimize shortening of the existing proximal femur and eliminate the need to strip periosteum proximally to identify the anchor pin sites. However, the cold-welded taper adapter was blocking access to the Compress nut, which holds the spindle onto the anchor plug traction bar.

**Figure 2** Intraoperative photographs. (A) The diaphyseal component (left) and spindle (right) after removal are shown; (B) the female end of the diaphyseal taper is held facing the camera, showing the fractured distal end of the taper adapter within.

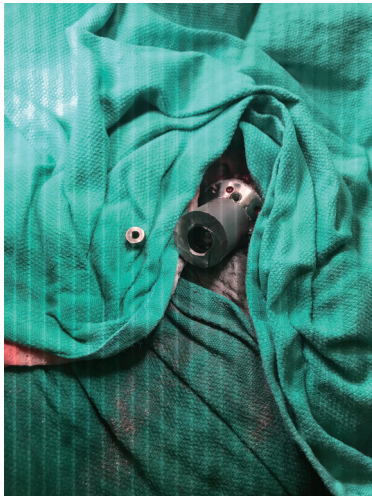
**Figure 3** Intraoperative photograph showing the spindle and proximal portion of the taper adapter still attached to the proximal femur. The distal aspect of the taper adapter has been resected (not pictured), allowing for removal of the compression nut (left side of photo) through the window created.

To gain access to the nut, the distal aspect of the taper adapter was resected using a metal-cutting wheel. This was done while taking extreme care to protect the soft tissues, using copious irrigation, and switching out cutting wheels when they became dull. Once the taper adapter was cut, the distal portion was removed and the Compress nut was accessed and removed (*Figure 3*). The anti-rotation pins were removed, and the spindle-bone interface was disrupted using a combination of flexible osteotomes and microsagittal and Gigli saws. Only a few millimeters of

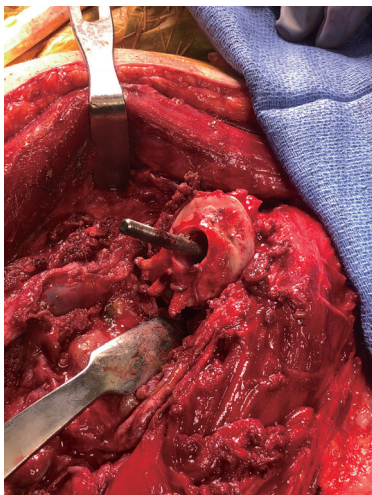
**Figure 4** Intraoperative photograph showing the end of the proximal femur after the spindle was removed. Only a few millimeters of bone had to be removed to disrupt the spindle-bone interface. The traction bar leading to the anchor plug is visible exiting the medullary canal.

proximal bone were removed (*Figure 4*). This stage was done very carefully, as removing too much bone could have resulted in an altered position of the spindle on the traction bar, potentially eliminating the ability to apply compression,

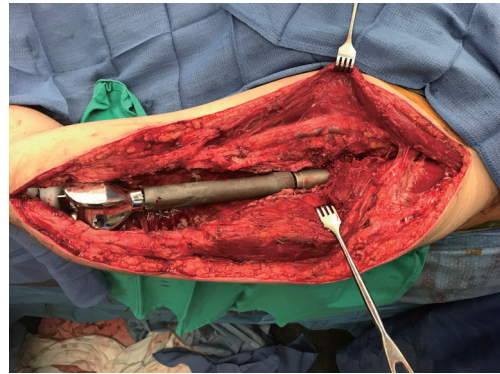
**Figure 5** Intraoperative photograph showing the final reconstruction. The new taper adapter is visible in the proximal aspect of the wound (right side of photo).

which would have resulted in the need for a more proximal anchor plug (6). We then freshened the bone surface, placed a new spindle, taper adapter, and diaphyseal segment, and completed the revision reconstruction (*Figure 5*). The wound was closed in layers over two deep drains, and the patient was kept protected weight-bearing with enoxaparin for thromboprophylaxis.
