Lost wire? Ultrasound can find it for you!

Abstract: The use of ultrasound (US) in clinical practice is becoming increasingly popular. This unique case highlights the importance of this technology in management of a complication arising from a central line placement in an intensive care unit (ICU).

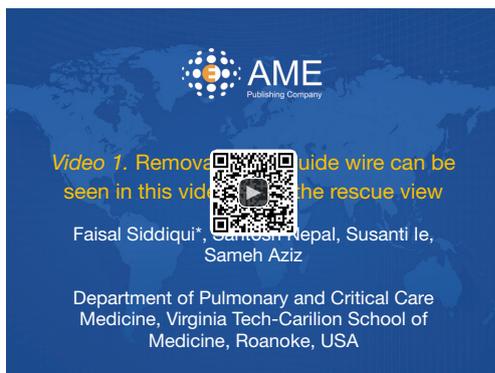
Figure 1 Removal of the guide wire can be seen in this video using the rescue view (1).

A 60-year-old female was admitted to intensive care unit (ICU) with septic shock. During her stay in the ICU she required placement of a central line for infusion of vasopressors and measurement of central venous pressure. For this purpose the right internal jugular (RIJ) vein was selected and real time ultrasound (US) guidance was employed for vein identification and patency. The operator experienced difficulty threading the wire but ultimately was successful. A 20 cm triple lumen central venous catheter was then placed utilizing modified seldinger technique. All three ports were aspirated and flushed. Post-procedure chest X-ray delineated a linear opacity extending beyond the length of the catheter and the diaphragm into the abdomen. US of the inferior vena cava (IVC) using lateral abdominal view (rescue view) revealed the presence of mobile hyperdense mobile object in the IVC consistent with retained guide wire which was inadvertently not pulled out during placement. It was then decided to pull the catheter with direct real-time visualization of the distal end of the guide wire using the US and the rescue view. The real time US guidance helped us monitor removal as wire was pulled out (see *Figures 1* and *2*). The catheter and the guide wire were removed *en bloc* without any complications.

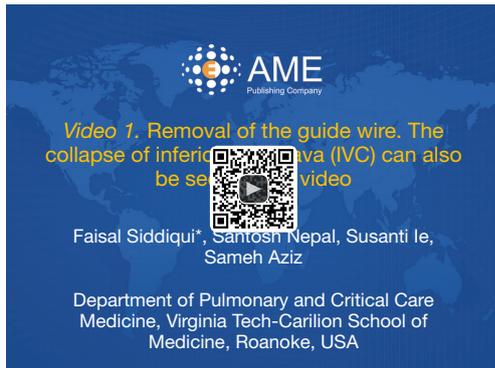
Figure 2 Removal of the guide wire. The collapse of inferior vena cava (IVC) can also be seen in this video (2).
