Traumatic rupture of the tricuspid valve and multi-modality imaging

Gustavo Avegliano, Mariana Corneli, Diego Conde, Ricardo Ronderos

Division of Cardiology, Instituto Cardiovascular de Buenos Aires, Buenos Aires, Argentina

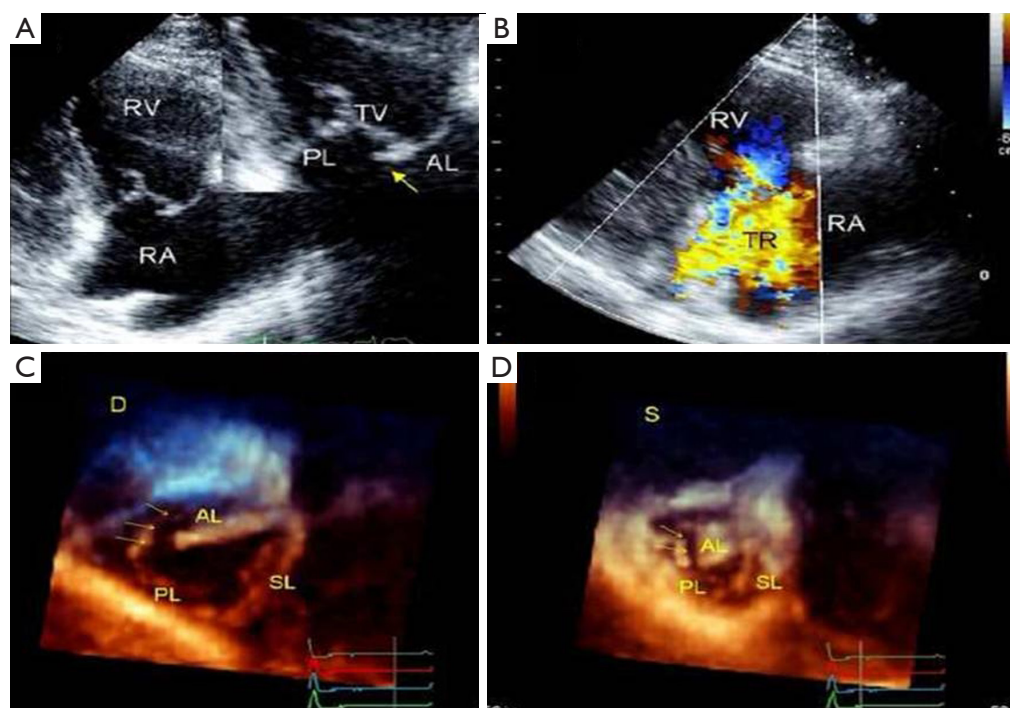
Figure 1 TTE. (A) Left: longitudinal view of the RV during systole. Note the linear structure in the mid-portion of the tricuspid anterior leaflet (arrow) consistent with cord rupture. Nevertheless, it is interesting to note that central coaptation is not lost; (B) right side: color Doppler image showing severe TR; (C) left: post-processed full volume image. Tricuspid valve is viewed from the RV (diastole). Note a tear in the body of the anterior leaflet (arrow) and not at the chord, as was suggested by 2D-TTE. The tear is observed from the free border to the annulus; (D) right: post-processed full volume image. Tricuspid valve is viewed from the RV (systole) tricuspid valve is closed and folded. Note the persistence of a linear image indicative of an anterior leaflet rupture (arrow). Data acquisition was performed by two experienced sonographers using an $\times 3$ matrix transducer connected to an RT-3DE system (IE33, Philips Medical Systems). Harmonic RT3DE imaging was performed in the same setting with the fully sampled matrix array transducer ($\times 4$, 2 to 4 MHz) that uses 3,000 elements to obtain a pyramidal volume data set from a single window. 2D-TTE, two-dimensional transthoracic echocardiography; RT3DE, real-time 3D echocardiography; RA, right atrium; RV, right ventricle; TR, tricuspid regurgitation.

cardiac silhouette. The electrocardiogram showed sinus rhythm. Two-dimensional transthoracic echocardiography (2D-TTE) revealed severe tricuspid regurgitation (TR) and a moderately dilated right ventricle (RV) with apparent normal systolic function (*Figure 1, Figure 1A*) (*Figures 2-5*). The precise mechanism for this valve dysfunction was not clearly defined; it appeared to be secondary of a cord rupture in the mid-portion of the tricuspid anterior leaflet. The right atrium was dilated with moderately increased intra-atrial pressure. The left ventricle and remaining valves were normal. For detailed assessment of the tricuspid valve and its surrounding structures, three-dimensional echocardiography was used.

in the body of the anterior leaflet and not at the cord, as was suggested by 2D-TTE (*Figure 1C*). Based on these findings, the mechanism was considered anterior leaflet rupture of the tricuspid valve, secondary to chest blunt trauma. Nevertheless, it is interesting to note that central coaptation is not lost, this probably acted to preserve some residual tricuspid valve function and the patient was not in clinical RV failure (*Figures 6, 7*).

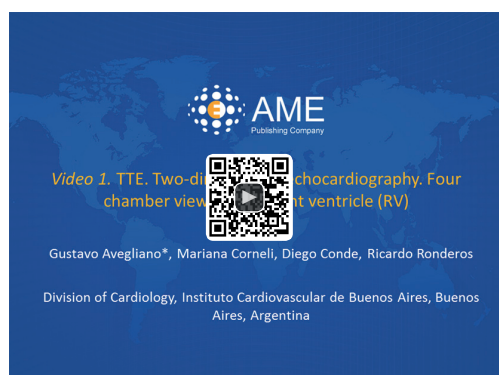
Figure 2 TTE. Two-dimensional echocardiography. Four chamber view for see right ventricle (RV) (4). Available online: <http://www.asvide.com/articles/310>

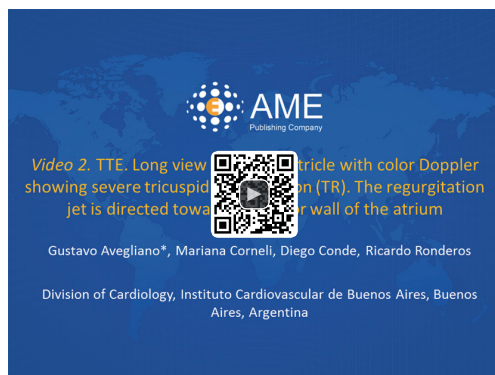
Figure 3 TTE. Long view of right ventricle with color Doppler showing severe tricuspid regurgitation (TR). The regurgitation jet is directed towards posterior wall of the atrium (5). Available online: <http://www.asvide.com/articles/311>

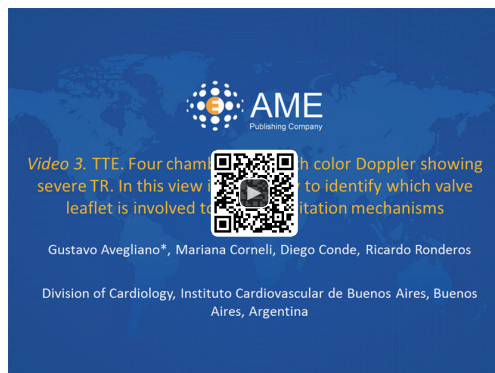
Figure 4 TTE. Four chamber view with color Doppler showing severe TR. In this view it is not easy to identify which valve leaflet is involved to the regurgitation mechanisms (6). TR, tricuspid regurgitation. Available online: <http://www.asvide.com/articles/312>

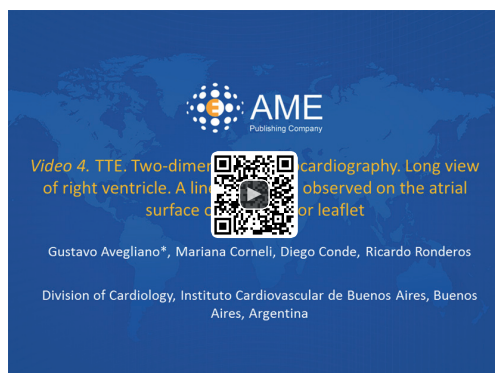
Figure 5 TTE. Two-dimensional echocardiography. Long view of right ventricle. A linear image is observed on the atrial surface of the anterior leaflet (7). Available online: <http://www.asvide.com/articles/313>

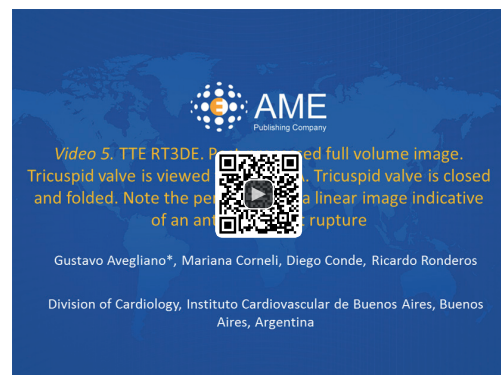
Figure 6 TTE RT3DE. Post-processed full volume image. Tricuspid valve is viewed from the RA. Tricuspid valve is closed and folded. Note the persistence of a linear image indicative of an anterior leaflet rupture (8). RT3DE, real-time 3D echocardiography; RA, right atrium. Available online: <http://www.asvide.com/articles/314>

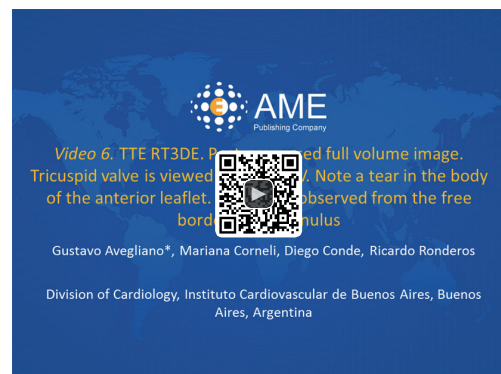
Figure 7 TTE RT3DE. Post-processed full volume image. Tricuspid valve is viewed from the RV. Note a tear in the body of the anterior leaflet. The tear is observed from the free border to the annulus (9). RT3DE, real-time 3D echocardiography; RV, right ventricle. Available online: <http://www.asvide.com/articles/315>

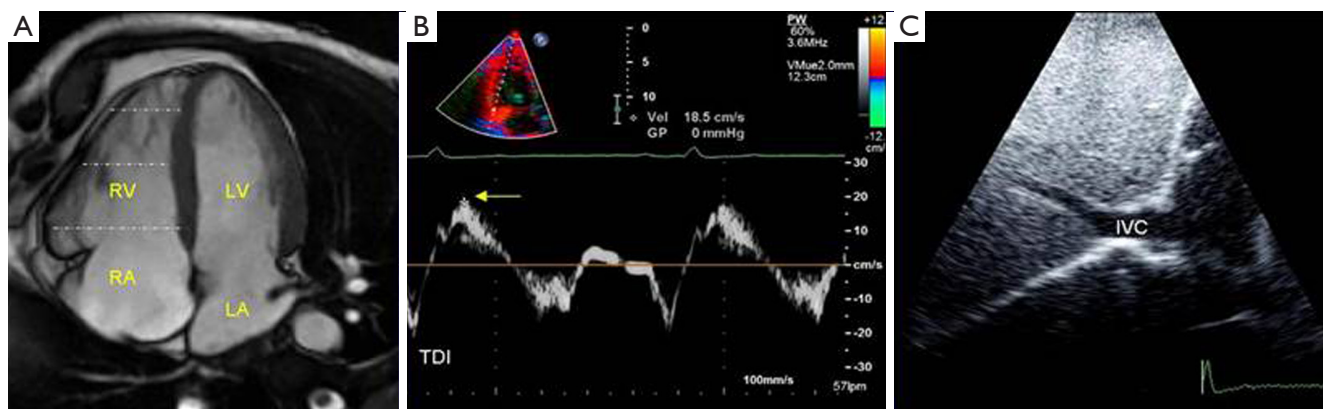
Figure 8 (A) Cardiac magnetic resonance: balanced steady-state free precession sequence (CINE). Four-chamber views during diastole showing the RV diameters at different levels. The volumes of the RV were 237 mL volume of end diastole and 130 mL for volume of end systole. The ejection fraction calculated for the RV was 45%; (B) tissue Doppler image. RV function by tissue Doppler imaging was normal (tricuspid annular systolic velocity >12 cm/s); (C) two-dimensional image of the inferior vena cava with normal inspiratory collapse suggest normal right-side cardiac and venous pressures despite volume overload. LV, left ventricle; RV, right ventricle; LA, left atrium; RA, right atrium; TDI, tissue Doppler image; IVC, inferior vena cava.

prior to tricuspid valve surgery (18-20). For the assessment of the RV, contractility parameters obtained with tissue Doppler or 2D-strain echocardiography, plus high quality volumetric and diameters data obtained with cardiac magnetic resonance provide an excellent combination for preoperative evaluation (Figure 8).
