Tissue-induced winding of permanent pacemaker passive-fixation leads

Yu Wang[#], Hongman Huang[#], Jianhua Sun, Jun Shi, Xinbing Liu, Liuliu Feng

Department of Cardiology, Shidong Hospital, Yangpu District, Shidong Hospital Affiliated to University of Shanghai for Science and Technology, Shanghai, China

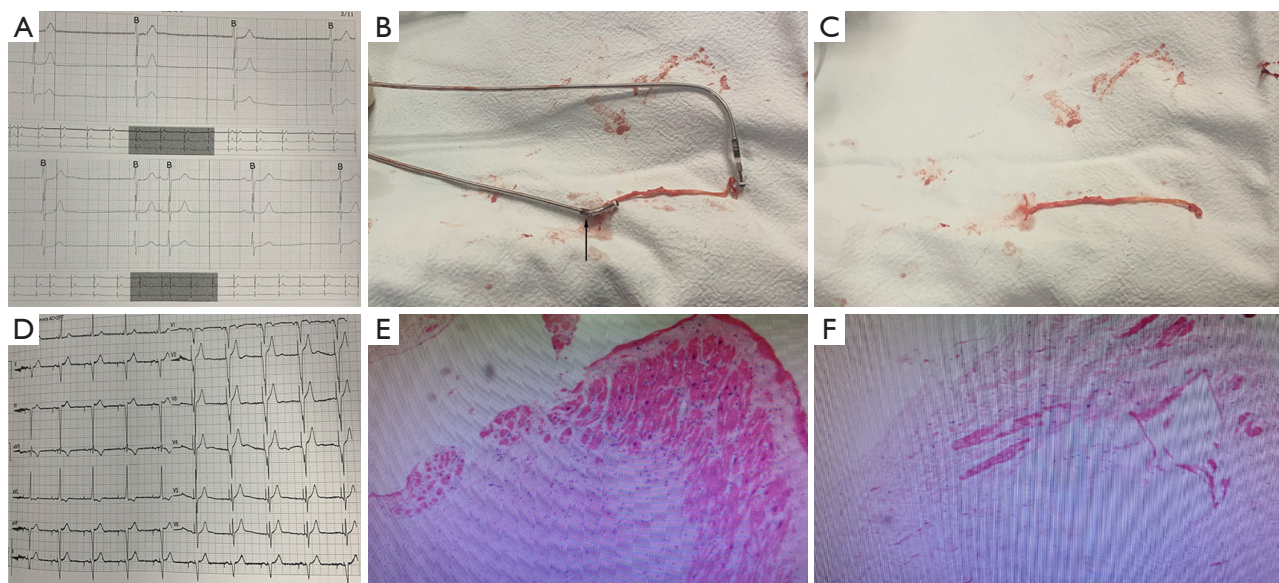
Figure 1 Electrocardiogram of the patient and photograph of the ventricular lead-tissue-atrial lead. (A) Representative picture of the 24-hour ambulatory electrocardiogram showed the diagnosis of SSS. (B) *In vitro* simulation of the relative position of ventricular lead-tissue-atrial lead. Arrow indicates the fracture site of ventricular fixation lead. (C) The shape of the tissue. (D) Electrocardiogram 1 hour after surgery. (E,F) Representative pictures of the HE staining ($\times 100$). SSS, sick sinus syndrome; HE, hematoxylin-eosin.

retraction of the atrial lead outside of the subclavian vein, a mass of tissue with unknown origin was found attached on the head of atrial lead, and the head of ventricular lead was attached on the other side of the tissue. *Figure 1B* simulates the relative position of ventricular lead-tissue-atrial lead. The shape of the tissue is shown *Figure 1C*; the tissue was sent for pathological examination [hematoxylin-eosin (HE) staining]. Another new ventricular and atrial lead were placed successfully and the pacemaker

was successfully implanted into the left infraclavicular subcutaneous pocket, and an electrocardiogram taken 1 hour after surgery revealed that the pacemaker was working correctly (*Figure 1D*). The patient had no relevant unpleasant symptoms during the operation. Transthoracic echocardiography performed 1 hour after surgery revealed no obvious cardiac lesion or perforation. The result of pathological examination showed the tissue consisted of smooth muscle (minority) and fibrous tissue (majority) (HE staining) (*Figure 1E,1F*).

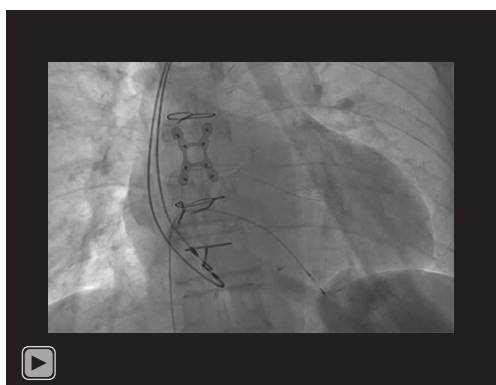
Video 1 Videoradiography showed the ventricular and atrial leads were fixed together by something.

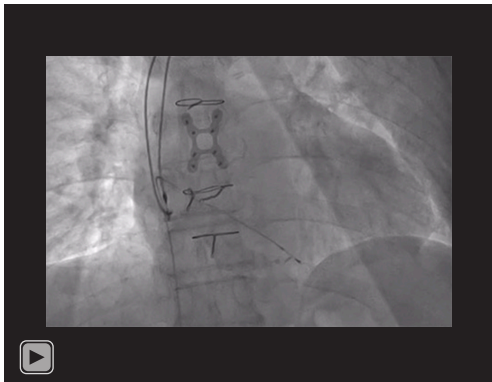
Video 2 Videoradiography showed the ventricular and atrial leads were closely connected and we could not separate them.

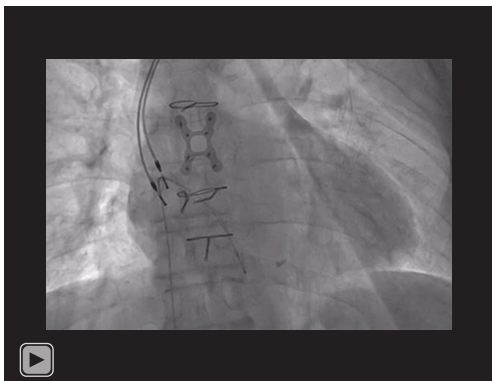
Video 3 Videoradiography showed that the ventricular and atrial leads were simultaneously retracted back to the puncture site of left subclavian vein.

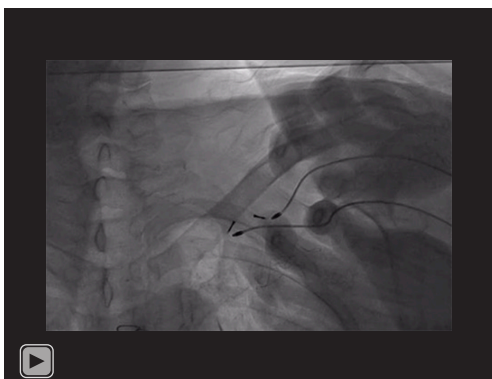
Video 4 Videoradiography showed the ventricular fixation lead was retracted from subclavian vein with relatively large forces, the head of ventricular fixation lead was then removed and remained in the subclavian vein during the retracting process.
