Supplementary

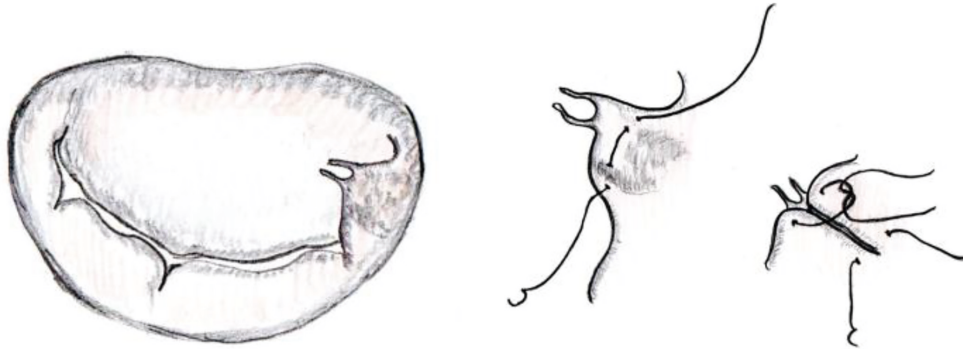
Figure S1 Folding repair. A temporary suture was placed, followed by an additional saline water test. Additional interrupted sutures were placed toward the annulus.
