Cardiac imaging in prosthetic paravalvular leaks

Carla Lázaro, Rocio Hinojar, Jose Luis Zamorano

Department of Cardiovascular, University Hospital Ramón y Cajal, Madrid, Spain

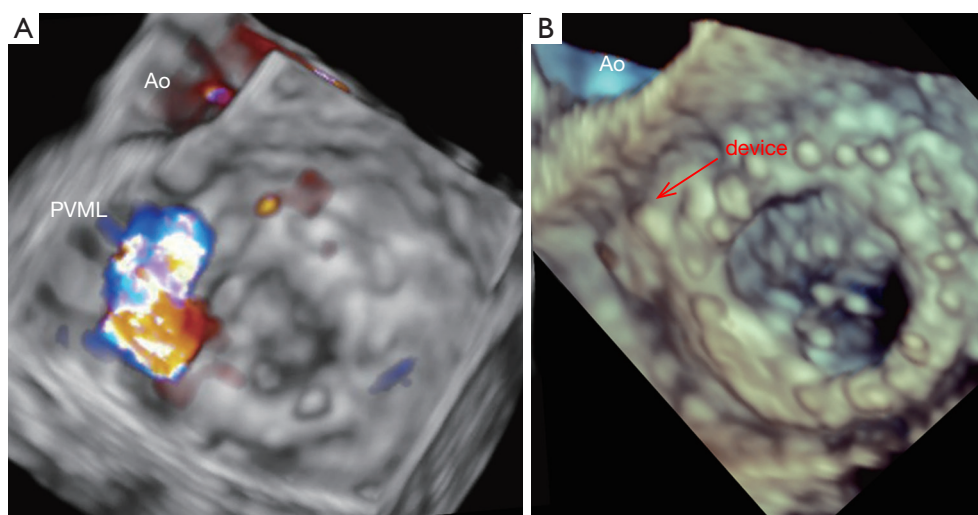
Figure 1 (A) Paravalvular mitral leak located in anterolateral position (10 o'clock); (B) closure device after paravalvular mitral leak closure.

As it was mentioned above, TTE is often performed as the initial imaging study, providing relevant information regarding chamber size and function, and evaluating the function of the prosthetic valve. Three-dimensional transoesophageal echocardiography (3D-TEE) is the most accurate technique to visualize the defect and to define its spatial characteristics: region of the defect, size and device selection (*Figure 1*).

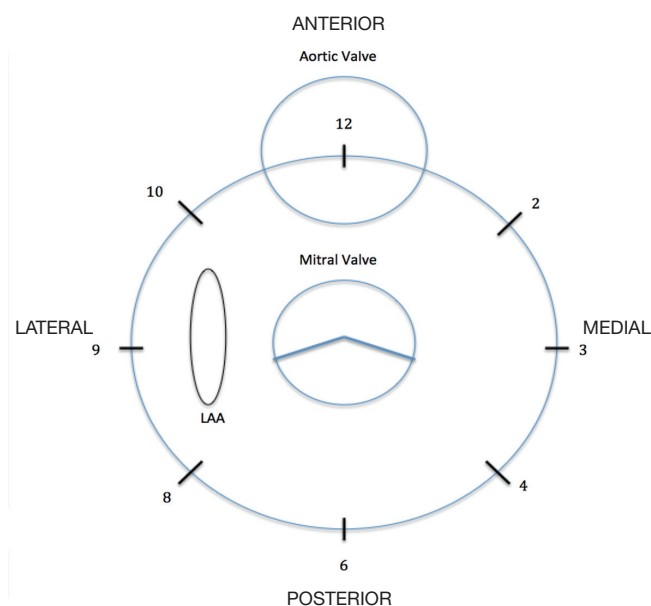
Figure 2 Diagram of the anatomic mitral view describing the location and extent of sites of paravalvular mitral regurgitation. Note the main references: ascending aorta (Ao) and left atrial appendage (LAA).

The angle at which the jet is first detected to the point of disappearance should be notice during the inspection of the valve to determine the extent of the leak. To describe the position of the leak and to facilitate the communication between the echocardiographer and the interventional cardiologist, internal landmarks such as the left atrial appendage, aortic valve and crux of the heart must be used (*Figure 2*) (16). Usually 3D images are orientated simulating the surgeon's perspective, assigning the "12 o'clock" position to the anterior mitral ring at the level of the aortic valve, and "9 o'clock" at the level of the left atrial appendage.

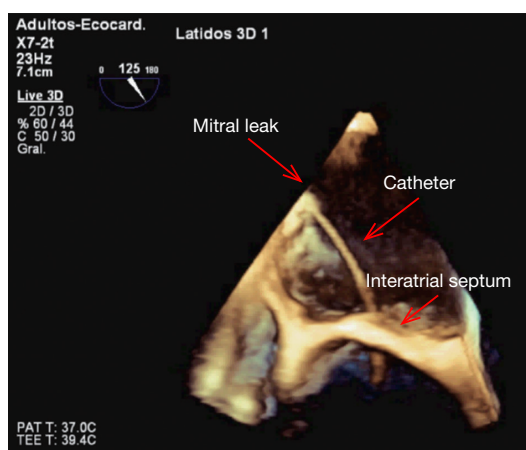
Figure 3 Catheter directed to the mitral leak, crossing the interatrial septum.
