# Intravascular imaging in Kounis syndrome: role of IVUS and OCT in achieving an etiopathogenic diagnosis

**Abstract:** We report a case of a 60-year-old male patient presenting with anaphylactic response to anchovies associated with an acute coronary syndrome. His history was remarkable for coronary artery disease treated with a drug eluting stent to the right coronary artery six years before and stent fracture documented by coronary angiography four years prior to the event. Coronary angiography on admission revealed a very late stent thrombosis (VLST) in the right coronary artery. Intracoronary imaging techniques (IVUS and OCT) were used and were key to discard main causes of VLST. We described the characteristics of intracoronary images, along with the advantages and disadvantages of these techniques. The findings described in this case could explain a new physiopathological mechanism of stent thrombosis occurring in stent fractures.

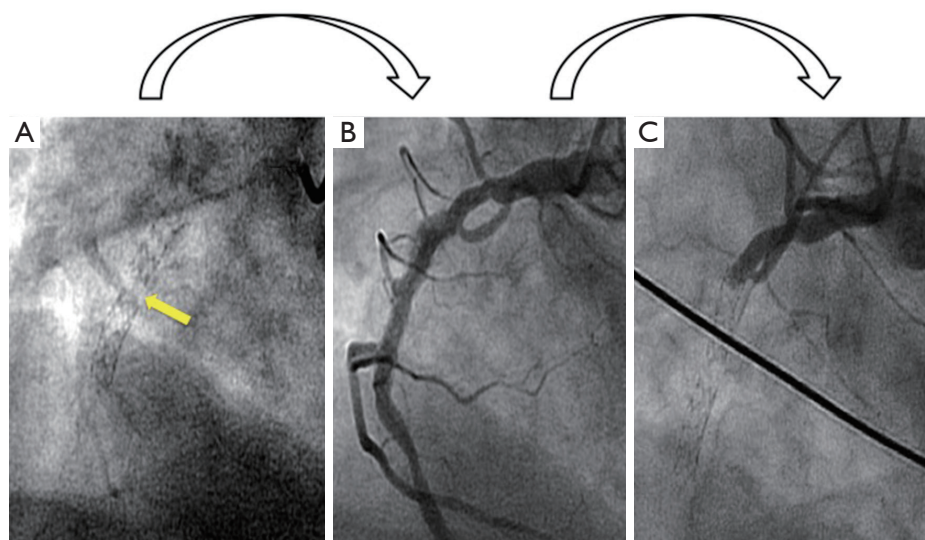
**Figure 1** Right coronary artery angiography. (A) Stent fracture (yellow arrow) documented four years before the event; (B) right coronary artery angiography without signs of restenosis in angiography four years before the event; (C) stent thrombosis of the previous implanted stent.

(*Figure 1A*) but no further therapy was conducted given the patient's excellent clinical status and the vessel patency (*Figure 1B*).

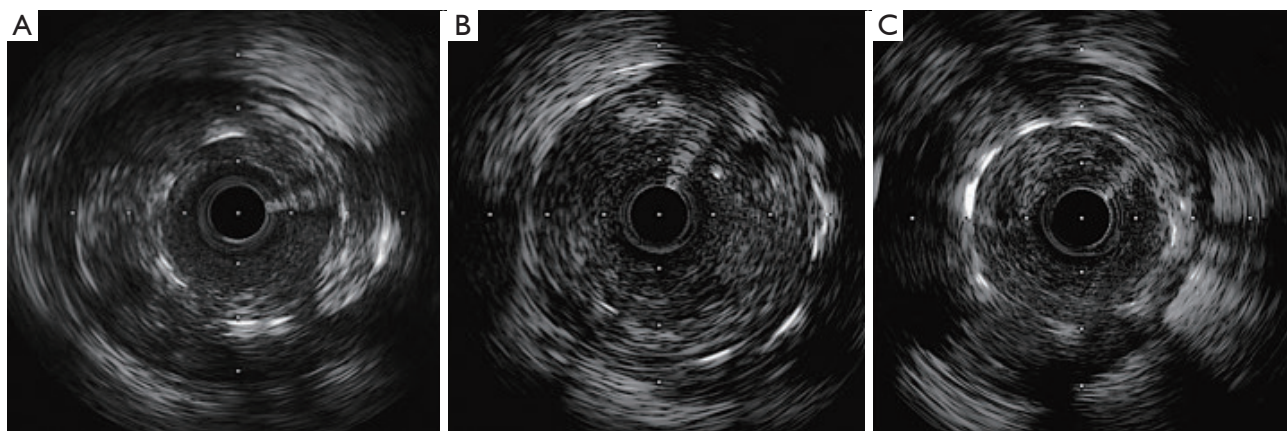
**Figure 2** IVUS images of the right coronary artery. (A) Pre fracture segment showing positive remodeling and adequate apposition and expansion of the stent; (B) stent fracture site showing intraluminal dense and homogeneous material compatible with thrombus, late restenosis or neoatherosclerosis; (C) post fracture segment, with persistence of echogenic material found in the stent fracture site.

defect persisted despite the previous maneuvers and in order to study the etiopathogenic diagnosis of this VLST, an intracoronary IVUS was conducted, demonstrating in addition to the stent fracture a positive remodeling of the artery with adequate apposition and expansion of the stent (Figure 2). However, at the site of stent fracture and distally there was a dense and homogeneous material, which IVUS was not able to differentiate between thrombus and late restenosis or neoatherosclerosis. An OCT was therefore performed, clearly demonstrating an irregular intraluminal

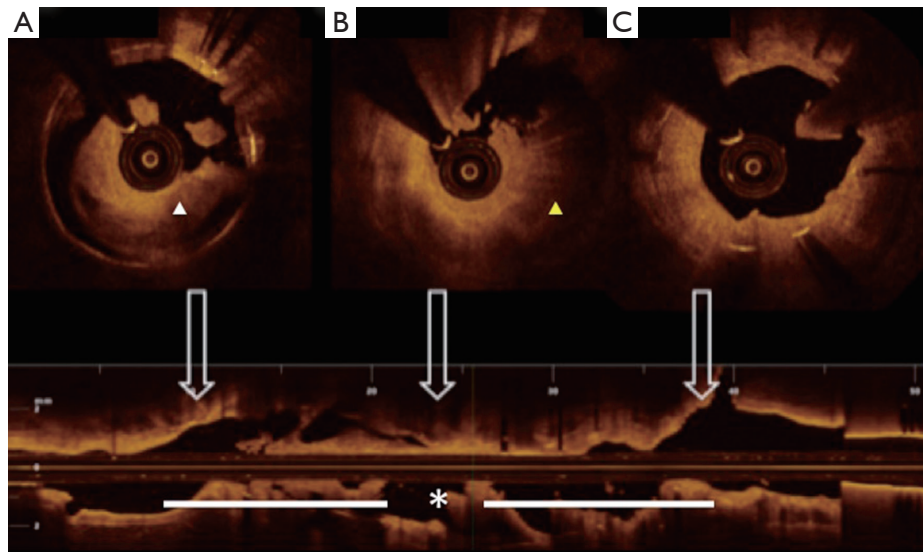
**Figure 3** Intracoronary OCT images confirming the presence of thrombus, mainly in stent fracture site (B), compared to distal (A) and proximal (C) regions. Inferior white line represents stent disposition, discontinued in fracture site (asterisk). Thrombus was characterized by an irregular intraluminal mass attached to the wall in the stent fracture site (B, yellow triangle) and freely floating distally (A, white triangle), with a signal-rich but non light attenuated compatible with white thrombus which allows to see the good apposition and expansion of the previous stent underlying the thrombus.

mass, signal-rich but without light attenuation, attached to the wall in the stent fracture site and freely floating distally. All this was compatible with the presence of a large amount of white thrombus, attached to the fracture site (Figure 3). The optical characteristics of the mass (very low light attenuation) also allowed OCT to better analyze the vessel wall characteristics distal to the thrombus, demonstrating the absence of restenosis or neoatherosclerosis, which IVUS was not able to recognize. Similar to IVUS, a good apposition and expansion of the underlying stent was seen.

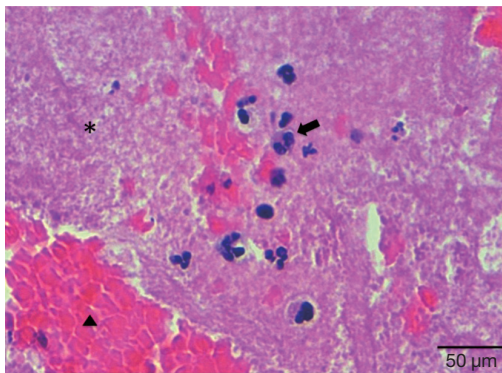
**Figure 4** Hematoxylin eosin staining of coronary thrombus, which consists of platelet aggregates and fibrin (asterisk) and white blood cells that included eosinophils (black arrow) and scarce red blood cells (black triangle) (magnification,  $\times 400$ ).

Department confirmed hypersensitivity to *Anisakis Simplex* with serologic tests. Pathological examination of the thrombotic material evidenced platelet aggregates, fibrin and white blood cells that included eosinophils. There were only scarce red cells (Figure 4). All of these features were compatible with a very early stage of white thrombus formation.
