# False blood leak alarm from dialysate discoloration following vitamin B12 infusion: case report

**Case Description:** We describe a case of a 55-year-old male with end-stage renal disease (ESRD) who received high dose vitamin B12 for refractory cardiogenic shock following a myocardial infarction. Several attempts at hemodialysis failed due to activation of the blood leak alarm and he was switched to continuous renal replacement therapy. His initial dialysate was red colored from vitamin B12 in the dialysate, which slowly cleared over 48 hours on dialysis.

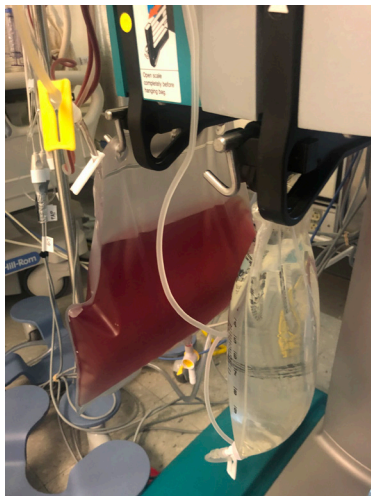
**Figure 1** Image of dialysate.

In the case presented, the dialysate turned a red color but no blood cells could be visualized in the dialysate, indicating a false blood leak. PrismaFlex, NxStage and Gambro Phoenix X36 dialysis machines utilize a single optical emitter using infrared wavelengths and are not influenced by visible spectrum dialyzable chromophores, which allowed the patient in our case to undergo CRRT (6). Others have reported false blood leak alarms on IHD machines in patients undergoing hemodialysis shortly following administration of vitamin B12 due to the production of red dialysate with successful hemodialysis after converting to CRRT machines (7-11).

Given the recent administration of high doses of vitamin B12 a false blood leak alarm was suspected and it was decided to use another type of dialysis machine (PRISMA) which utilizes a single optical emitter sensor and does not activate in the presence of visible spectrum chromophores in the dialysate. A right internal jugular dialysis catheter was placed and continuous renal replacement therapy (CRRT) was initiated. The dialysate collection showed a red effluent which did not show any red blood cells on microscopic examination, confirming a false blood leak (*Figure 1*). Over the next 24 hours, the patient's dialysate progressively cleared as the vitamin B12 was removed by dialysis.
