# Fire during pulmonary bullectomy by video-assisted thoracoscopic surgery

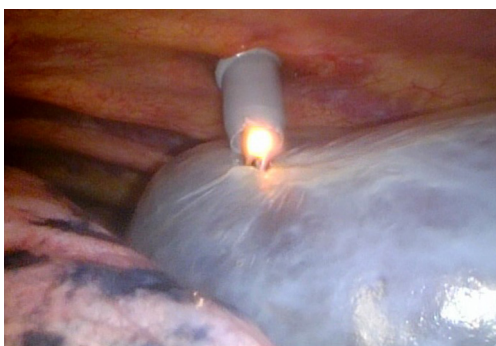
When we observed the thoracic cavity from first port, the lung was not sufficiently collapsed and a giant inflated bulla was blocking the third port. To rupture the giant bulla, we first tried to make a hole using grasping forceps. However, this was not possible because of the elasticity of the cyst wall. Next, we tried to use an electric scalpel through third port to rupture the giant bulla. When a hole was made in the bulla and it collapsed, the Thoracoport burned (*Figures 1 and 2*). The Thoracoport was removed and extinguished immediately. The patient and staff in

**Figure 1** Photograph showing the Thoracoport on fire when a hole was made in the giant bulla using an electric scalpel.

The remaining intrathoracic oxygen and the use of an electric scalpel near the Thoracoport are thought to be factors that contributed to the fire. Thoracoport is made of flammable polyethylene. The use of an electric scalpel in this situation resulted in the presence of the three elements required for a fire, namely, an oxidizer, fuel, and ignition source, resulting in burning of the Thoracoport.

In conclusion, we reported a case in which a fire occurred when a hole was made in a giant bulla using an electric scalpel. The oxygen density in the peripheral airway is high enough to cause a fire. Therefore, when an expanded bulla needs to be removed, it is more preferable to use

scissors, a scalpel, or a needle rather than electrosurgical equipment. Furthermore, it is important to communicate with the anesthesiologist during the perioperative period, particularly in cases in which pneumothoraxes on both sides are operated on simultaneously.

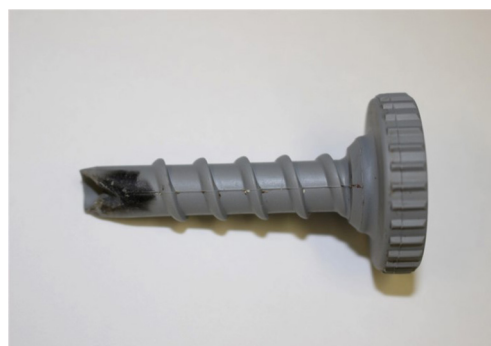
**Figure 2** The burnt end of the Thoracoport.
